EVALUATING FIRE PERFORMANCE OF NAIL-LAMINATED TIMBER

March 10, 2019

Client: Forestry Innovation Investment Ltd.

EVALUATING FIRE PERFORMANCE OF NAIL LAMINATED
TIMBER
PROJECT NO. 301013024

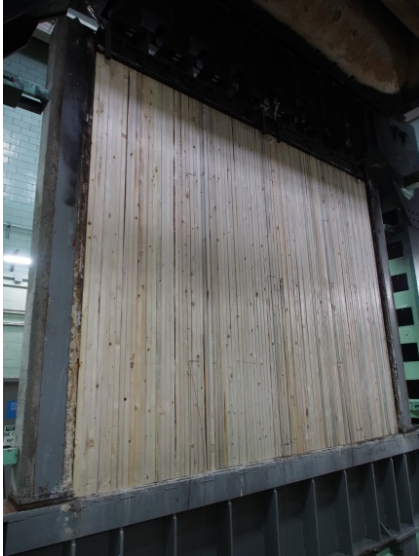
The NLT surface was not perfectly level due to natural variability of the boards and manufacturing methods. This meant that in some cases that gypsum board joints did not meet straight on, where one protruded out further than the adjacent board, as shown in Figure 11. This created a disparity at the joint and an air gap behind the gypsum board in some locations. The final exposed surface of the 2x8 NLT wall assembly is shown in Figure 12.

Figure 11. 2x8 NLT Gypsum board disparity.

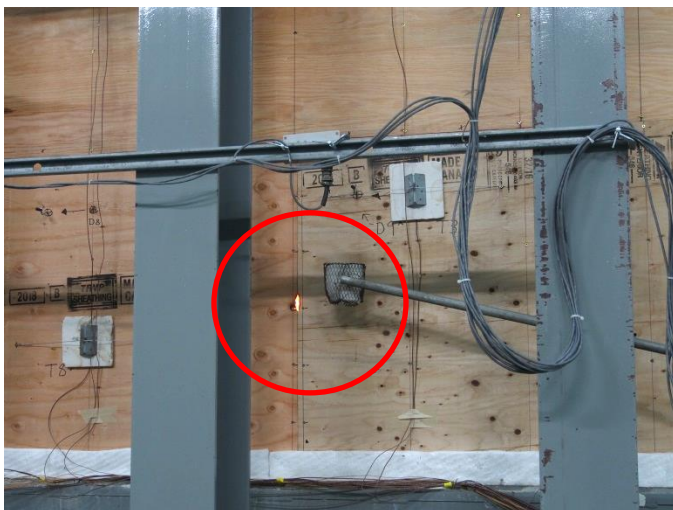
After 33 minutes from the start of the test, integrity failure occurred at a plywood joint; ignition of a cotton pad was used to confirm the failure, as shown in Figure 18. Once burn-through was detected a piece of plywood was used to cover the spot, which allowed the test to continue. Additional burn through spots occurred at 50 min, 52 min, and 63 min, each of which was also covered with a piece of plywood to continue the test to structural failure. These secondary spots were all through the plywood layer and not at a plywood joint. Figure 19 shows a plywood cover over the primary integrity failure and a secondary failure close by. The test ran until structural failure occurred at 71 min. Figure 20 shows the exposed side of 2x6 wall at the end of the test, and Figure 21 shows the condition of the exposed side after the wall had cooled. There appeared to be a depression in the wall at the location of the first burn-through, where more charring had occurred. This is consistent with the location of the negative pressure drawing more air in at the bottom of the furnace. Figure 22 shows the structural failure of the wall, deflecting out of the furnace.

Figure 18. 2x6 NLT wall insulation failure.

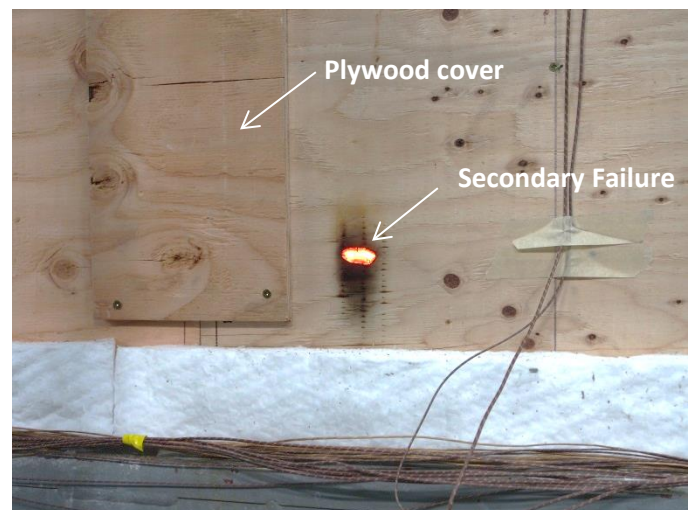
Figure 19. 2x6 NLT wall plywood cover and secondary insulation failure.

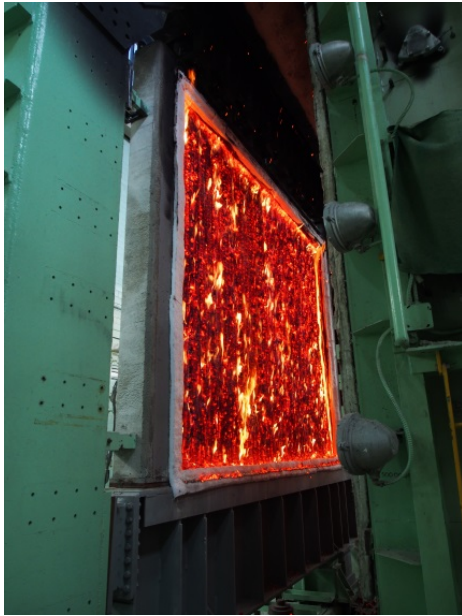
Figure 20. 2x6 NLT wall at end of test.

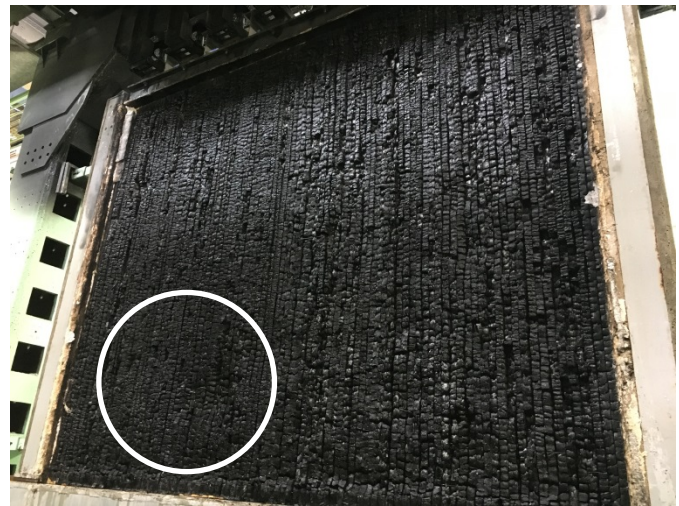
Figure 21. 2x6 NLT wall surface after test, depression.

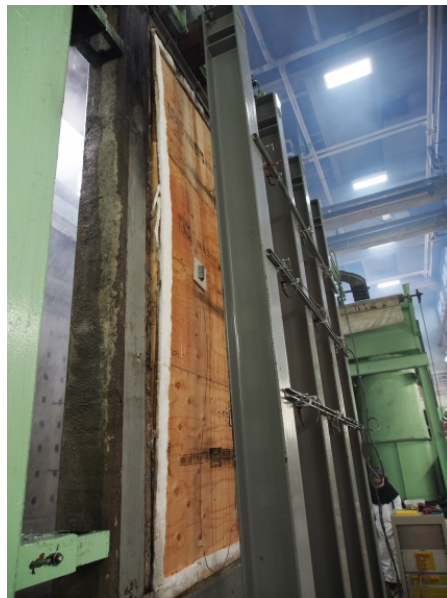
Figure 22. 2x6 NLT wall structural failure, deflection.

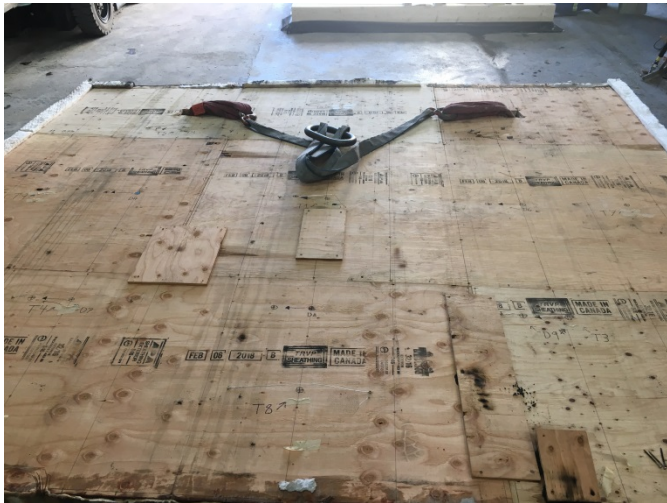
Figure 26 shows the unexposed wall surface after it has been removed from the furnace, with various locations of plywood installed to cover locations of burn-through.

Figure 26. 2x6 NLT wall layout of added plywood pieces.

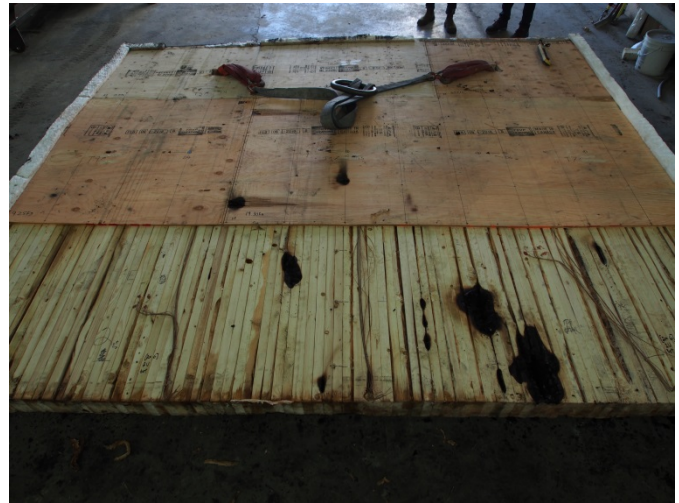
After the test, the plywood on the unexposed side of the assembly was removed to assess the condition of the NLT itself. Figure 27 shows the wall assembly with some of the plywood panels removed, revealing the extent of burn-through at different locations. A section was cut to evaluate the depth of charring around the location of the first burn-through where there appeared to be the most significant depth of charring. The cut section is shown in Figure 28. Figure 29 shows the typical depth of char at a location where no burn-through occurred. The residual depth was determined to be between 75 to 85 mm based on physical measurements and a resistograph.

Figure 27. 2x6 NLT wall unexposed surface after plywood removal.

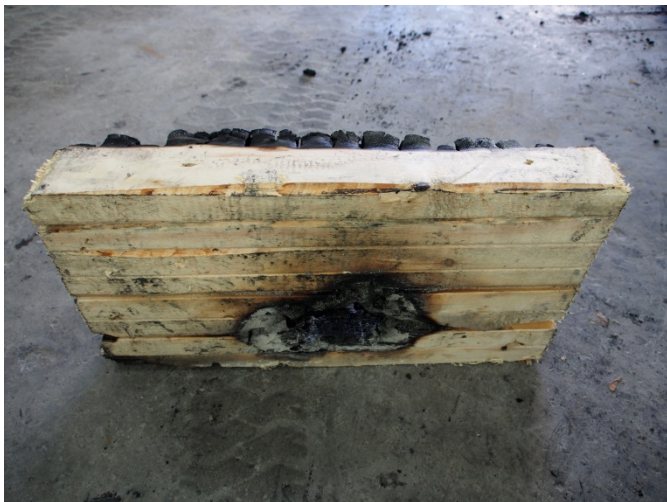
Figure 28. 2x6 NLT wall section taken at primary failure.

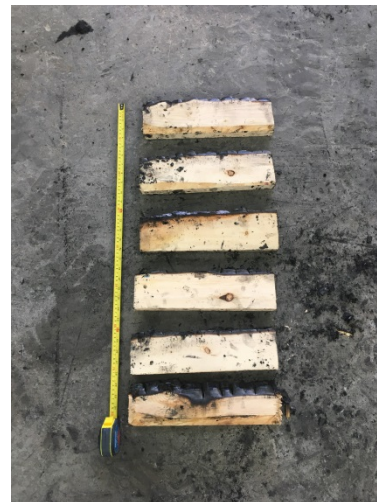
Figure 29. 2x6 NLT wall typical depth of char.

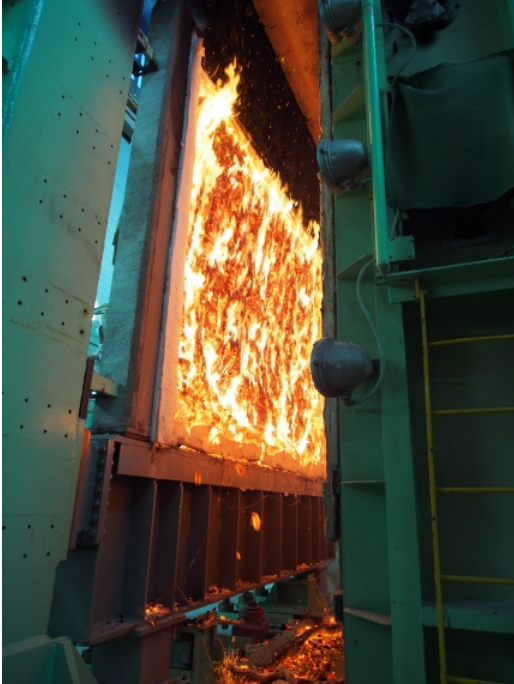
Figure 30. 2x8 NLT wall after test.

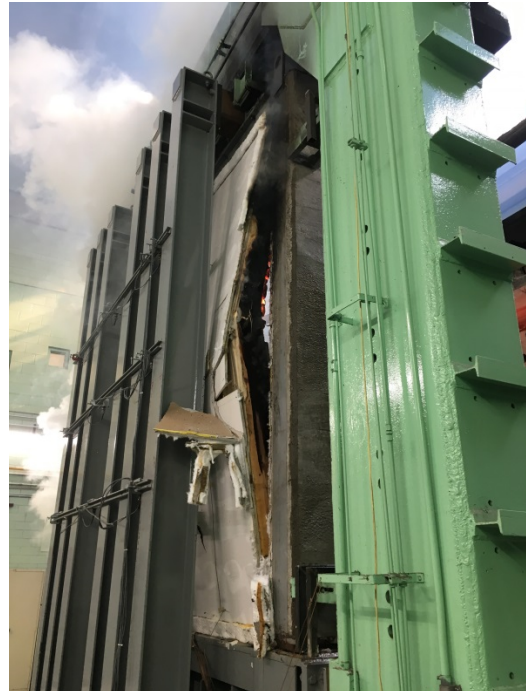
Figure 31. 2x8 NLT wall structural failure.

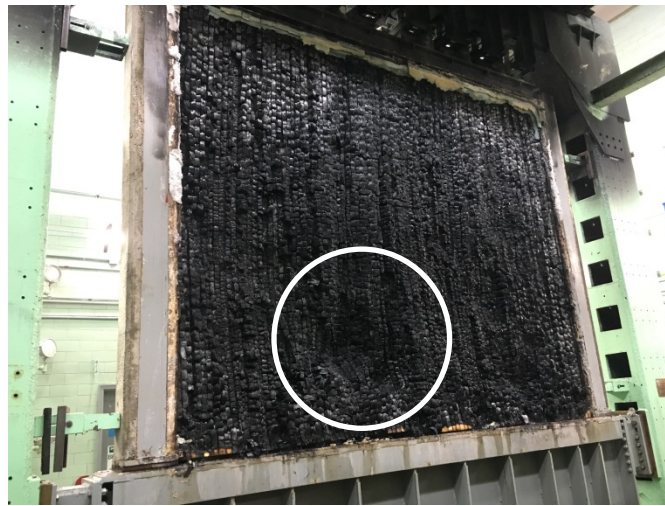
Figure 32. 2x8 NLT wall exposed surface after test, depression.

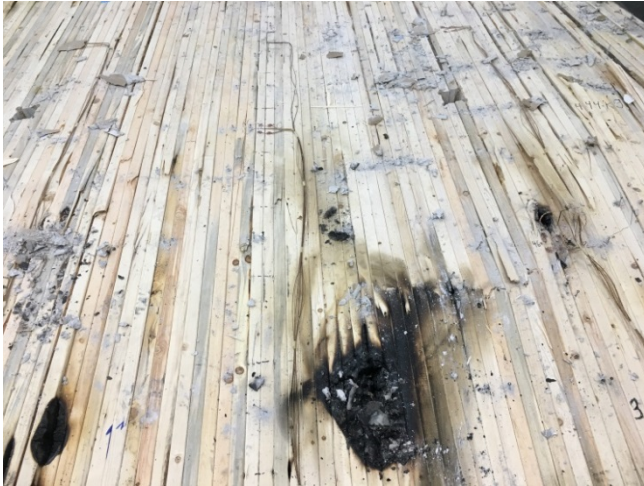
Following the test the gypsum board was removed from the unexposed side of the assembly to inspect the condition of the NLT. Figure 36 indicates three locations of burn-through that were observed. The largest spot, in the centre of the figure, is associated with the location of increased char depth noted on the exposed side, and coincided with where the wall cracked during structural failure. A section was cut from the wall to assess the depth of char. The wall was also pulled apart to investigate how charring varied along the height of the wall, as shown in Figure 37. The residual depth was determined to be between 90 to 95 mm based on physical measurements and a resistograph.

Figure 36. 2x8 NLT wall unexposed surface after test, gypsum removed.

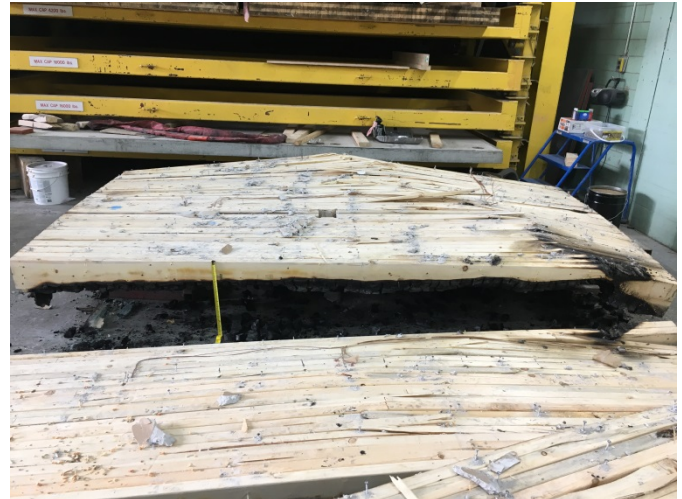
Figure 37. 2x8 NLT wall depth of charring along length of board.

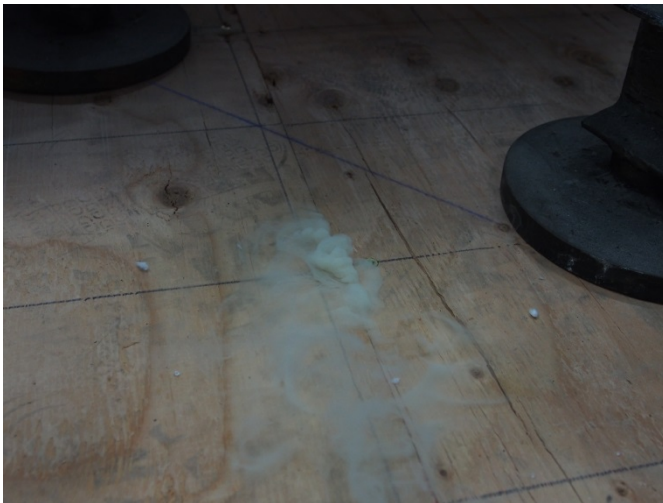
At the beginning and periodically during the test, light smoke leakage came through at some of the plywood joints, as shown in Figure 39. The test was stopped 101 min into the test because the temperature in the exhaust exceeded a safety threshold. This is thought to be a result of increasing deflection which may have exposed uncharred wood between the boards, i.e., opened up gaps between the boards. Figure 38 shows temperature measurements at the nine locations inside the furnace, as well as the average and the standard fire curve. Around 90 min, three readings began to increase beyond the standard fire temperature, while the others began to decrease. With this overall average decrease in temperature, it is thought that the automated system tried to compensate by adding more propane to the furnace. This ultimately led to a fuel rich environment and a lack of oxygen which limited the ability for burning to occur inside the furnace. As the gases were exhausted it mixed with oxygen and was then able to burn, thus burning occurred in the exhaust pipe and raised the temperature within the exhaust beyond safe levels. At this point the furnace was turned off.

Figure 39. 2x6 NLT floor intermittent light smoke leakage during test.

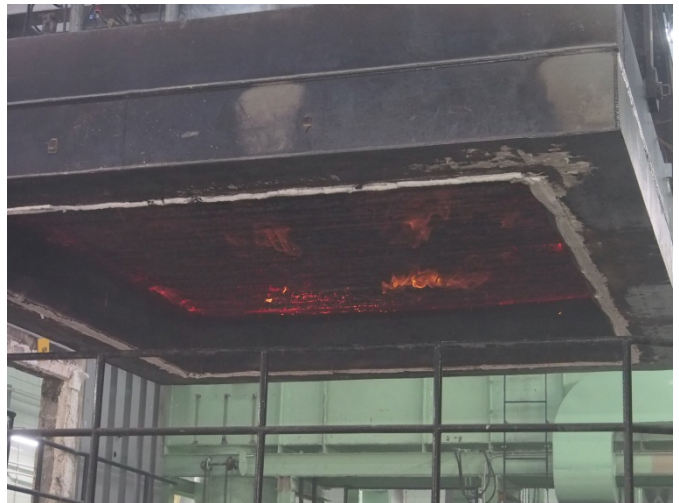
Upon inspection of the assembly after the test, it was evident that structural failure would likely have occurred soon had the test not been stopped. Figure 40 shows the removal of the floor from the furnace. Figure 41 shows the charred surface of the floor after it had cooled and Figure 42 shows a location of burn-through (that occurred after the furnace was turned off). Once the furnace was turned off, the dynamics inside the furnace change, which could partially explain why burn-through occurred shortly later. It takes a few minutes from the end of the test until the assembly can be removed from the furnace and any remaining flames extinguished, which is an opportunity for the assembly to continue to burn. At these post-test burn-through locations, increased charring must have been occurring during the test for burn-through to occur so quickly after the test.

Figure 40. 2x6 NLT floor removal from furnace.

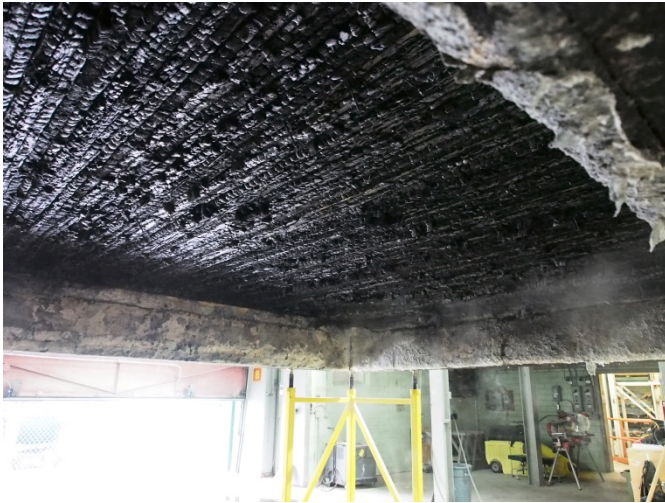
Figure 41. 2x6 NLT floor condition of exposed surface after test.

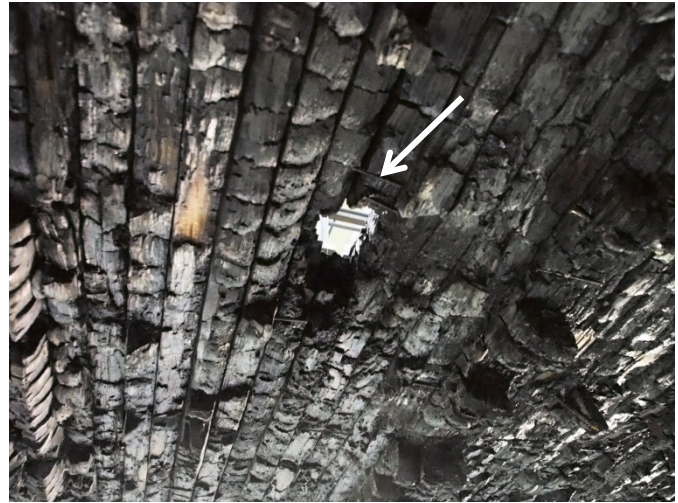
Figure 42. 2x6 NLT floor burn-through after test.

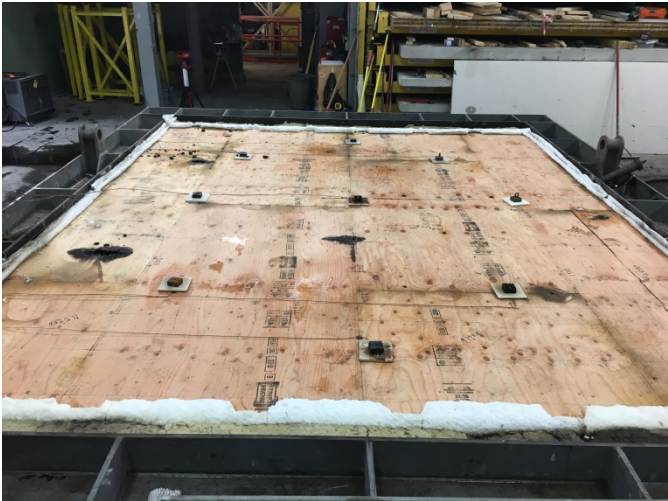
Following the test, the condition of the assembly was assessed. The unexposed side of the assembly after the test is shown in Figure 45. There was discolouration at some plywood joints where smoke leakage had occurred. Five locations of charring through the assembly and plywood were noted, which occurred after the test had ended. Figure 46 shows a close-up view of one spot from the unexposed side. The plywood was removed to assess the overall condition of the NLT, as shown in Figure 47. For the majority of the assembly there was no evidence of charring behind the plywood. A sample was cut to evaluate the typical depth of char, as shown in Figure 48. The residual depth was determined to be between 65 to 75 mm based on physical measurements and a resistograph.

Figure 45. 2x6 NLT floor unexposed surface after test. Charring through plywood after end of test.

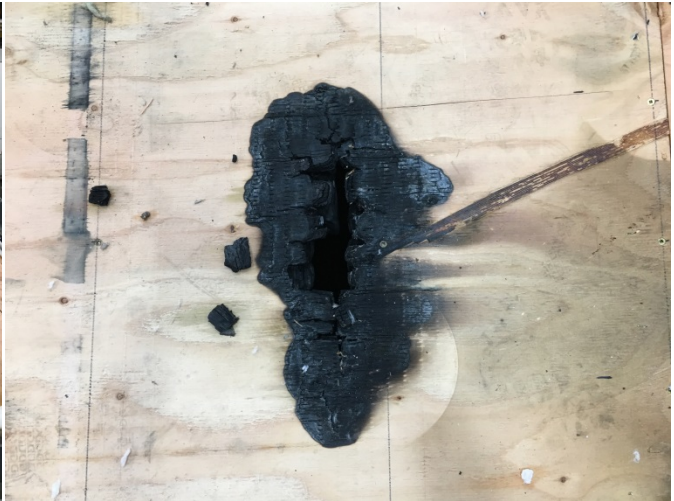
Figure 46. 2x6 NLT floor location of burn-through.

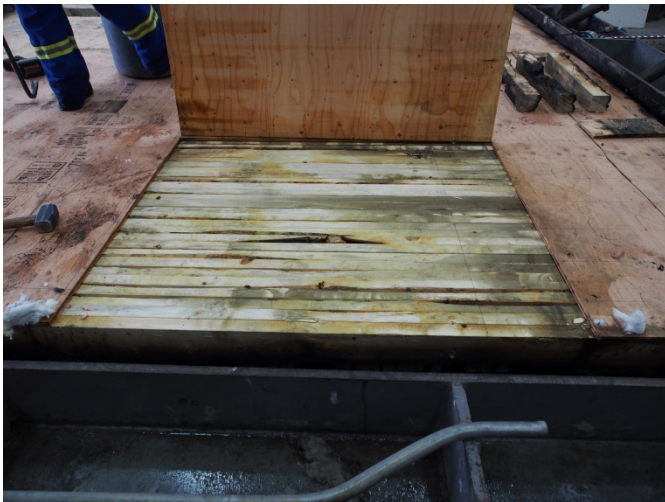
Figure 47. 2x6 NLT floor condition of NLT unexposed surface, plywood removed.

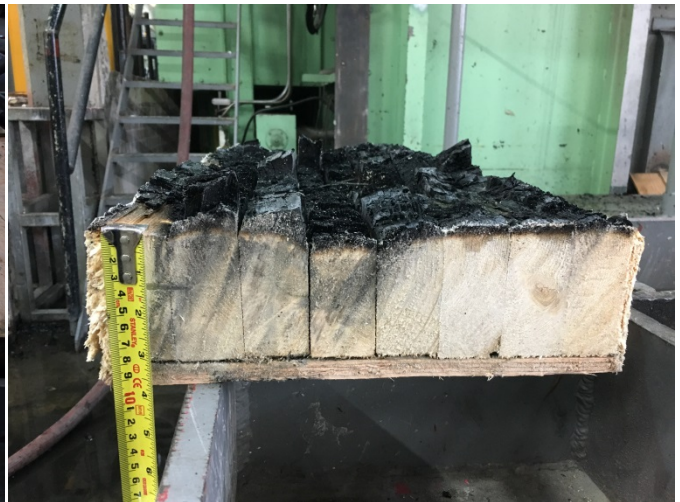
Figure 48. 2x6 NLT floor depth of char in cut sample.

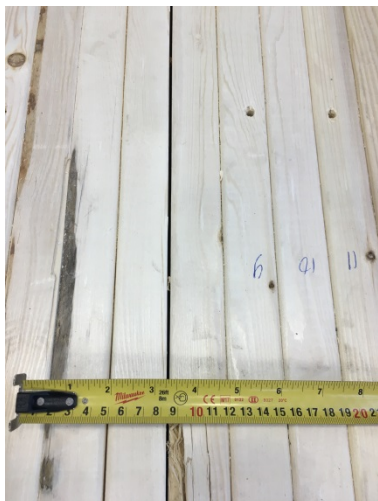
Because of the nature of NLT as a product, using multiple lumber boards laminated together, the natural imperfections in the lumber can impact the quality of the assembly. There are various defects that are typical in lumber such as twisting, cupping, bowing, wane, etc. These can result in two boards not pressed in full contact with each other, which can create gaps or pockets between the boards which can lead to localized increased charring rates. Figure 49 to Figure 51 show examples of gaps that formed during construction of these assemblies. Care should be taken in the selection of boards for use in NLT to limit the creation of these kinds of gaps. It may be prudent to press boards together during nailing, to increase contact between boards to improve quality and fire resistance. Moisture content of boards should be monitored to avoid unnecessary creation of gaps due to wood shrinkage once assemblies are in service. These measures will help to minimize and limit the size and number of gaps between boards, which should reduce the possibility of integrity failures. Additional layers of protection on the unexposed side which create an air barrier may also limit charring at these gaps if it prevents airflow through the system. A cross-section of NLT is shown in Figure 52, indicating that the surface is not perfectly smooth. This can affect the application of direct applied gypsum board, but creating local air gaps behind the board. More research is warranted to investigate methods to address local integrity failure in NLT assemblies.

Figure 49. Gap between NLT boards.

This research demonstrates that NLT can be designed to safely meet various FRR requirements. It is important that protection be provided on the unexposed side of assemblies to limit air flow to address the potential of integrity failures due to gaps that can form between NLT boards. Care should be taken during construction to limit the creation of gaps, such as by pressing boards during nailing or quality control checks to remove any boards with excess bends, twists, wane, etc. Moisture content should also be controlled to inhibit the creation of gaps due to wood shrinkage during service conditions.

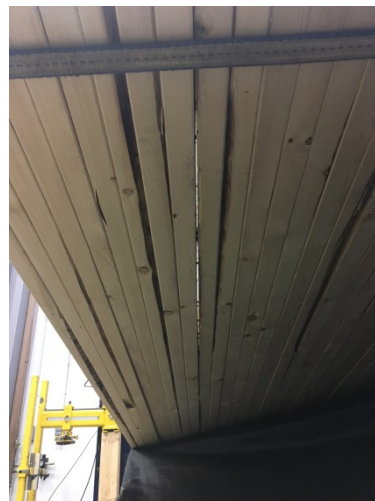
Figure 50. Light able to pass through assembly.

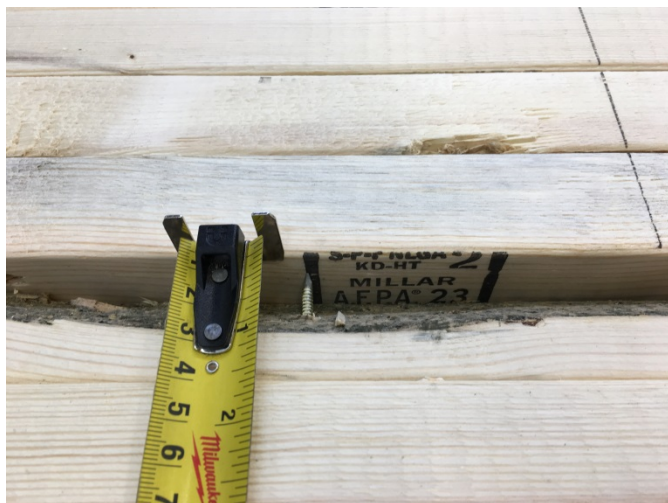
Figure 51. Gap due to wane.
