# WIRL Building Research Report

WOOD INNOVATION RESEARCH LABORATORY

# Introduction

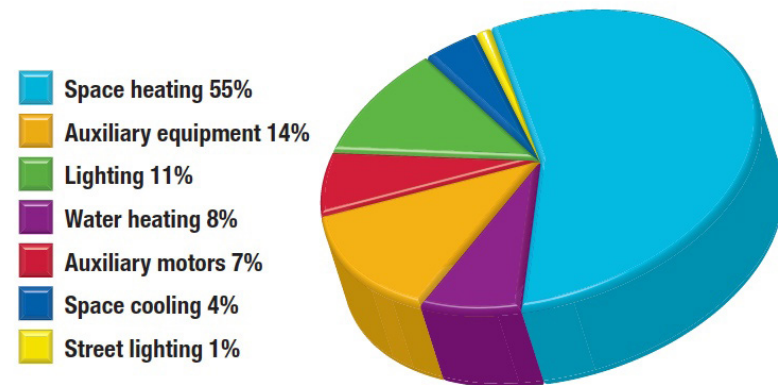
Figure 1. Commercial/institutional energy use by end use, 2013 (Natural Resources Canada, 2013).

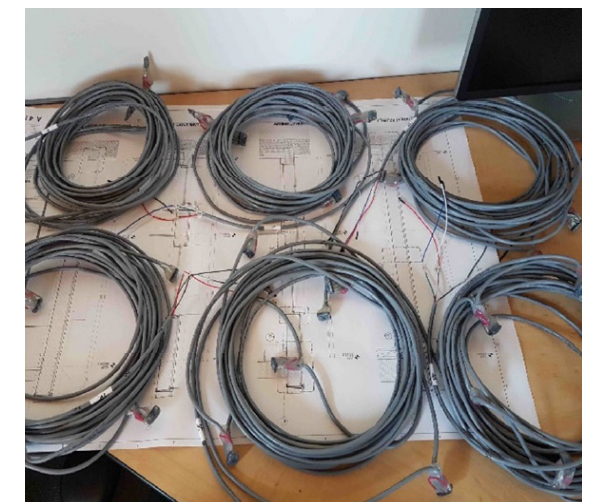
The temperature sensors (MCP9808) and humidity sensors (SHT31-D) were soldered to a four-pole 16-gauge wire. The sensor strings for each assembly terminated at one Raspberry Pi controller located adjacent to the given sensor string bundle located on the north and south exterior walls of the building and southwest corner where the floor sensors were installed. For some of the sensor string bundles the distance between the sensor and controller was relatively significant.

A thick wire gauge was selected because of the large distances between the sensors and controllers to reduce the resistance in the set-up. The length of the wire between each sensor was significantly longer than the actual distance between the sensors to reduce the influence of thermal conductivity of the cables on the sensors. We produced six prototype sensor strings given these specifications (Figure 3), and then sealed each with hot glue to avoid any moisture damage while inside the wall.

Figure 3: Sensor Wires.

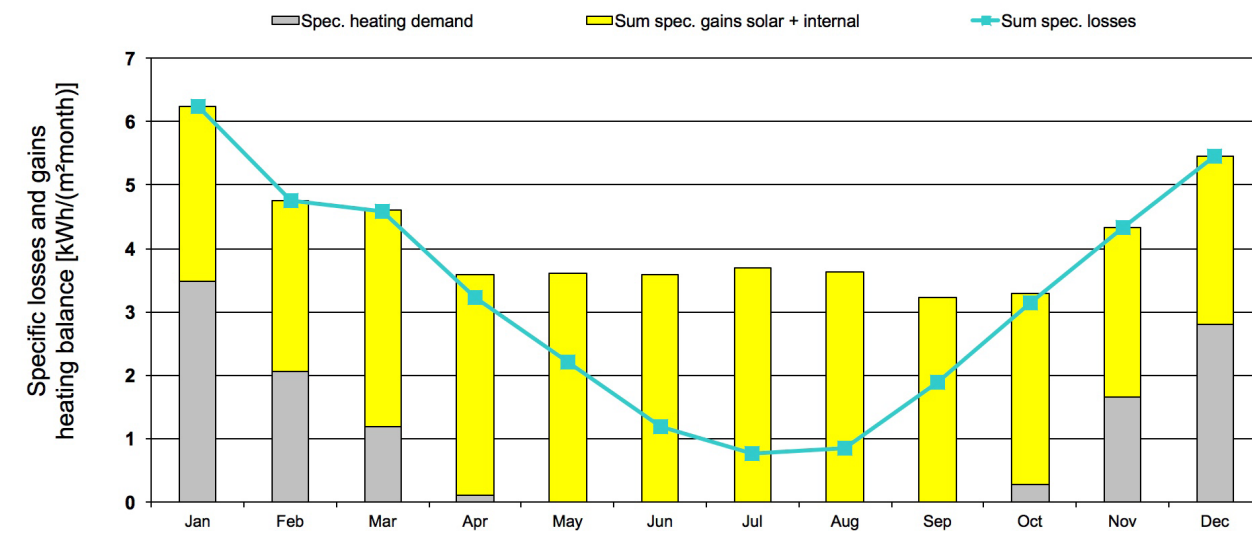
Based on the given assumptions for space and hot water use in the building as calculated by the PHPP program, the total specific heating demand is as shown in Figure 5. The actual natural gas consumption as measured by the gas meter installed on the building for the period of December 6 to 31, January 1 to 31 and February 1 to 28 is shown in Figures 6 and 7.

Figure 5. Calculated specific heating demand by month as calculated by the Passive House Planning Package (PHPP) program.

- For the month of December, PHPP predicted a total specific heat demand of 2.8kWh/m2 , or 28916.2kWh of energy use (using a total conditioned floor area of 1041.5m2). In contrast, the meter installed on the building shows a total cumulative consumption of 3.3kWh/m2 of natural gas, or 3436.28kWh.
- For the month of January, the PHPP model predicted a total specific heat demand of 3.5kWh/m2, or 3645.25kWh. The gas meter recorded a total consumption of 3.3kWh/m2, or 3452.53kWh.
- For the month of February, the PHPP model predicted a total specific heat demand of 2.1kWh/m2, or 2187.15kWh. The gas meter recorded a total consumption of 4.2kWh/m2, or 4416kWh.

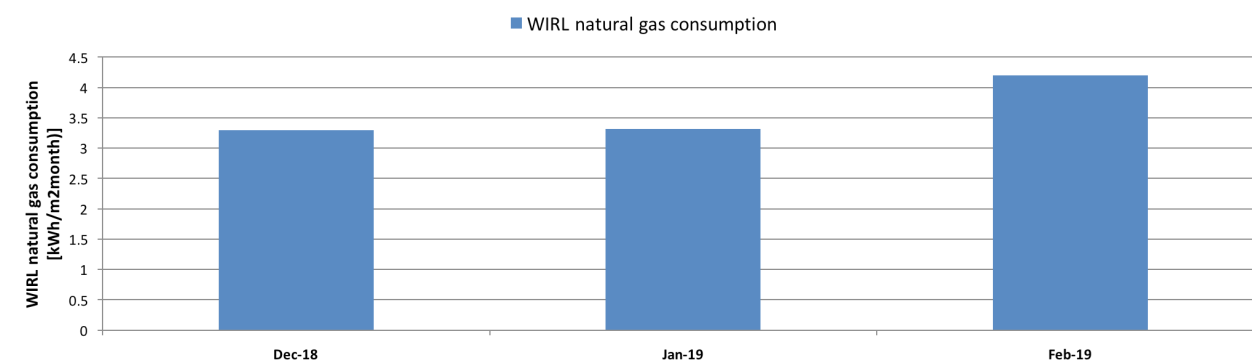
Figure 6. Total monthly gas consumption (kWh/m2month) as collected from the gas meter installed on the WIRL building for the period of Dec. 6 2018 to Feb. 28, 2019.

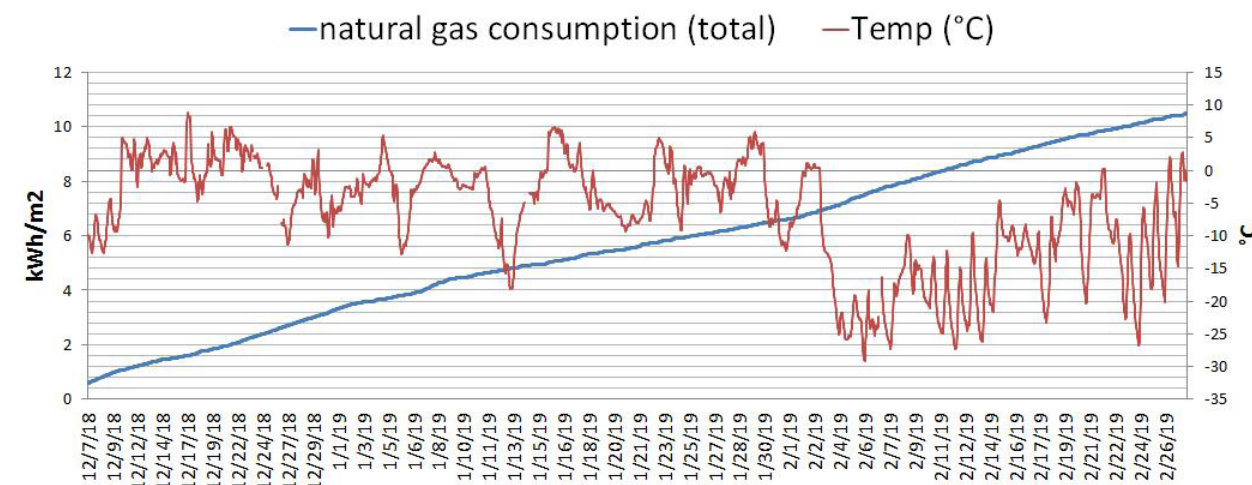
Figure 7. Cumulative natural gas consumption (kWh/m2) vs temperature (°C) for the period of Dec. 7 to Feb. 28 2019.

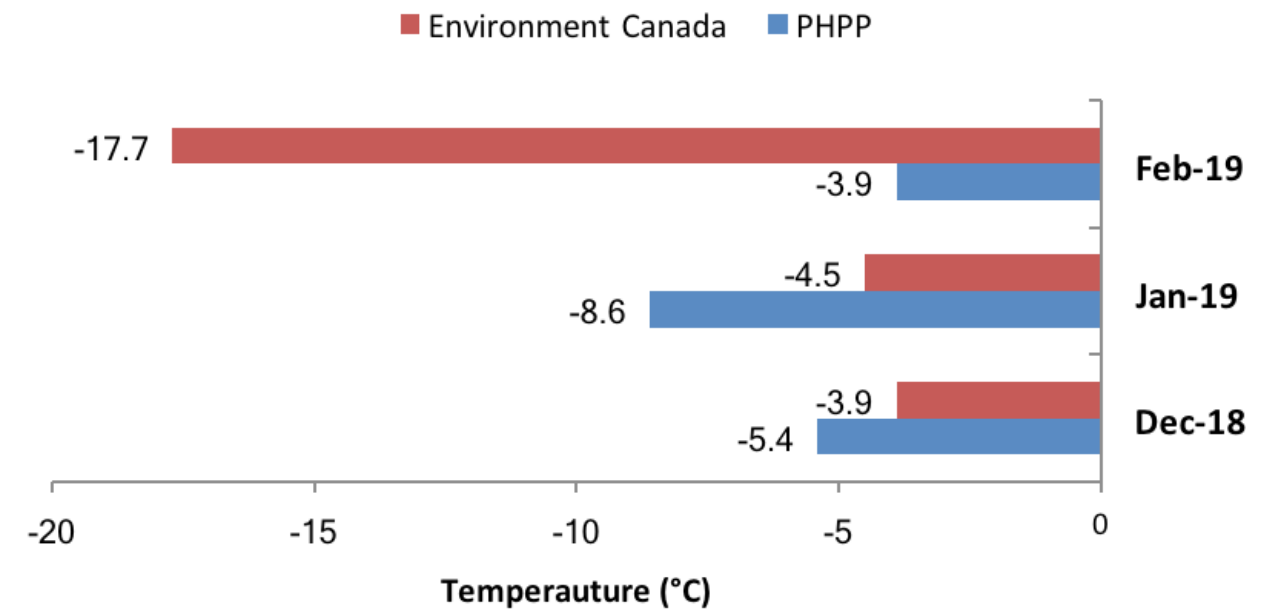
The first cause of discrepancy that can be found between the PHPP model and actual performance of the WIRL building is in the climatic data used in the PHPP model versus the actual recorded temperatures for the months during which gas consumption has been recorded. These values can be seen in Figure 8.

Figure 8. Modeled ambient temperature vs. actual weather data for WIRL building.

From Figure 8 we can see that discrepancies exist between the ambient temperatures used in the PHPP model versus the actual recorded average temperatures for Prince George for the months of December 2018 and January and February of 2019. February 2019 shows a particularly large difference between the two values, which may be accounted for in the fact that it was the coldest February on record in the city's history, with an average temperature of -17.7°C. For the month of January, PHPP used an average ambient temperature of -8.6°C, while the actual measured average temperature was -4.5°C. This is reflected in the heating energy use for the building, which is 0.2kWh/m2 lower than the predicted heating energy demand by PHPP.

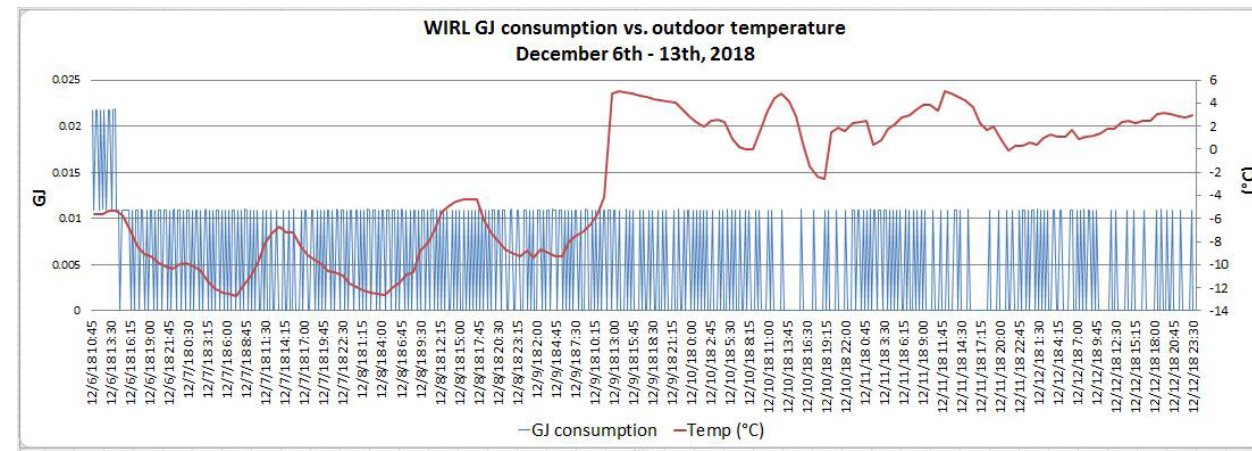
actual gas consumption for the month, which is 520kWh of consumption. In reviewing the consumption data for the remaining reporting period (Figure 9), we find that the consumption is consistent thereafter. Therefore, we feel confident that the discrepancy for energy consumption for the period of December can be accounted for in the startup errors in the gas metering device.

Figure 9. Gas consumption data for WIRL building, recorded on 15min intervals.

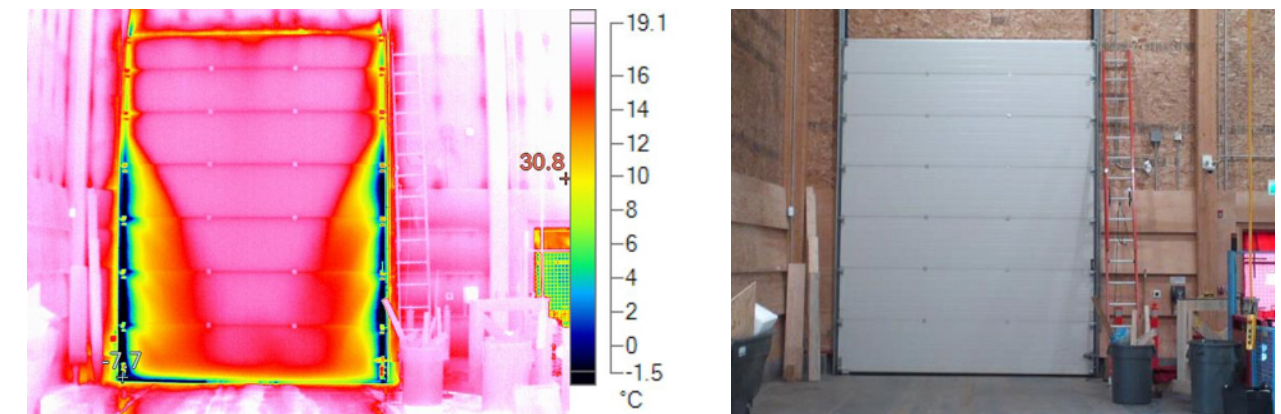
Figure 10 shows the large bay door for semi-trucks. Throughout airtightness testing we established already that this door, even though the highest quality available today, is still a weak point in terms of thermal performance and air tightness. The picture shows the infiltration of cold air in the lower section of the door symmetrically on both sides. It can be assumed that during regular operating condition of the building this area is a significant source of warm air exfiltration.

Figure 10. Thermographic image of the WIRL bay door (left) and corresponding visible light image (right) taken during the follow up air leakage test conducted on Feb. 6, 2019.

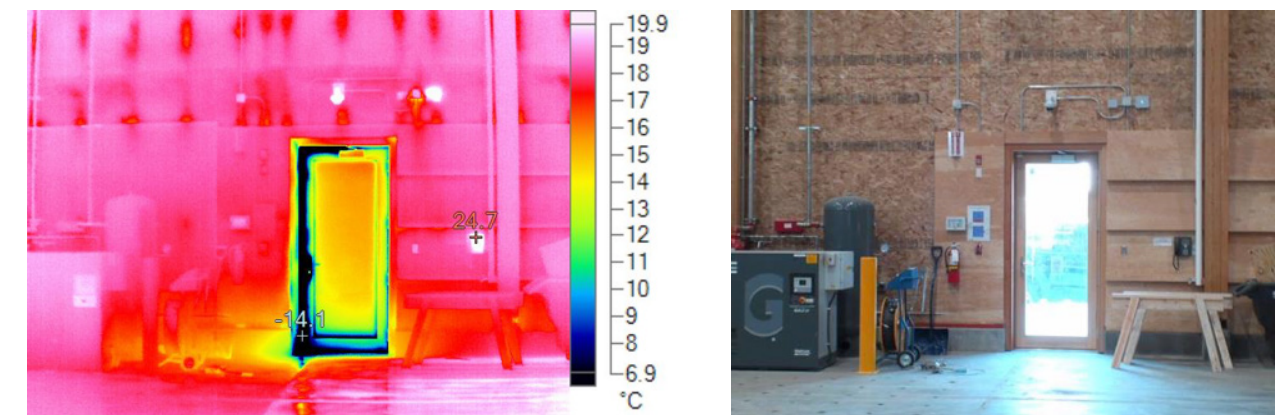
Figure 11 shows cold air infiltrating mainly on the opening side of the north wall entry door due to a malfunctioning seal between the door and frame.

Figure 11. Thermographic image of the north entry door (left) and corresponding visible light image (right) taken during the follow up air leakage test conducted on Feb. 6, 2019.

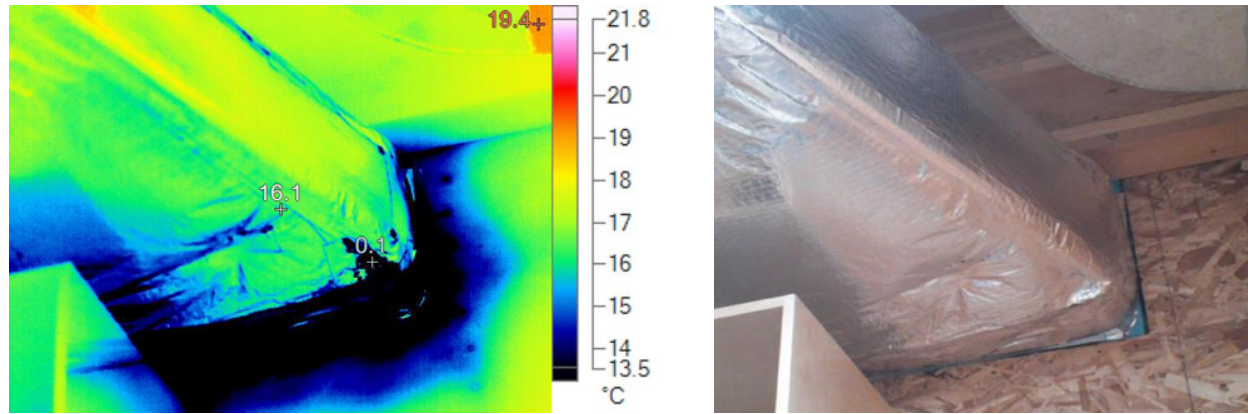
Figure 12 shows the cold air intake of the Heat Recovery Ventilation System (HRV). It is normal that the cold air intake would show lower temperature since exterior air is sucked into the building through this duct, however in addition we can see some lack of airtightness at the perimeter of the insulated ductwork.

Figure 12. Thermographic image of the HRV cold air intake (left) and corresponding visible light image (right) taken during the follow up air leakage test conducted on Feb 6, 2019.

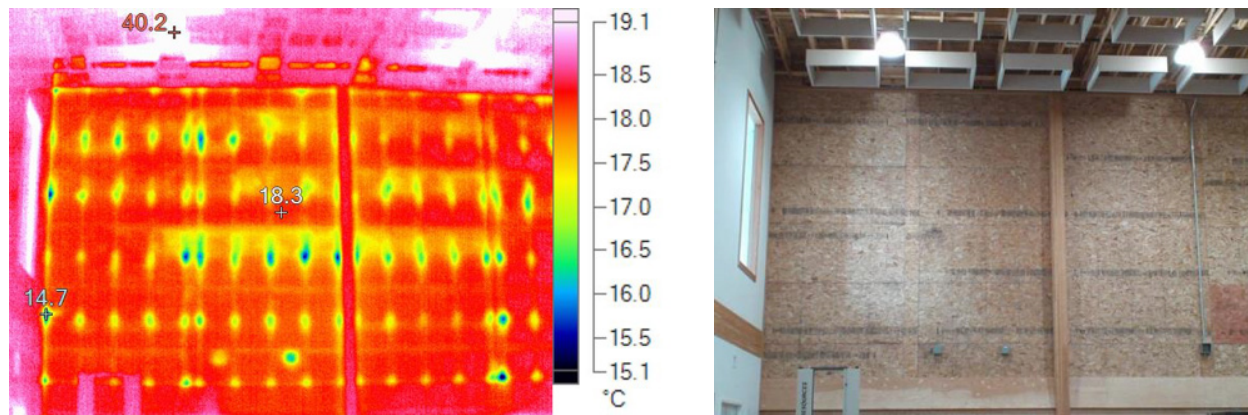
Figure 13 shows the wall structure and the minor thermal bridges caused by the truss systems of the exterior wall assembly. These point loads are not related to air tightness but a result of the last few remaining thermal bridges in the envelope. The thermal performance of this wall is better than an equivalent stud wall would have been.

Figure 13. Thermographic image of the west exterior wall (left) and corresponding visible light image (right) taken during the follow up air leakage test conducted on Feb 6, 2019.

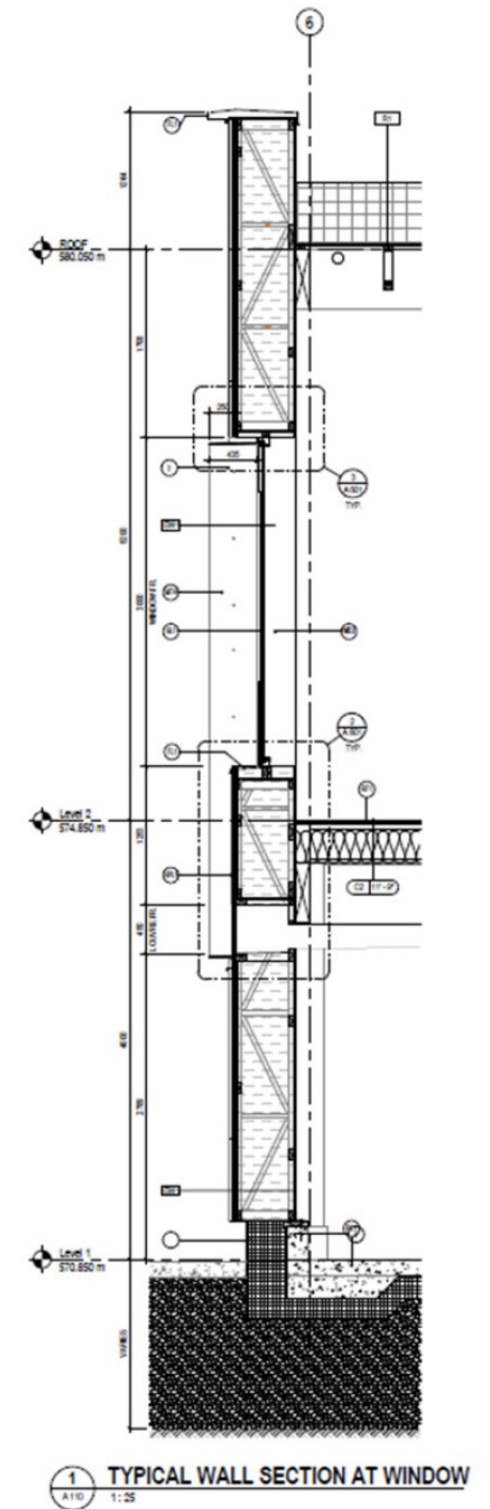
The exterior walls of the Wood Innovation Research Lab were constructed using 508mm thick vertical truss panels filled with mineral fiber insulation. The panels were sheathed on both the interior and exterior side with oriented strand board (OSB), with a vapour diffusion resistant adaptable membrane installed on the exterior face of the interior OSB sheathing for airtightness and vapour diffusion control (Figure 14).

Figure 14. Cross-section diagram of Wood Innovation Research Lab exterior wall.

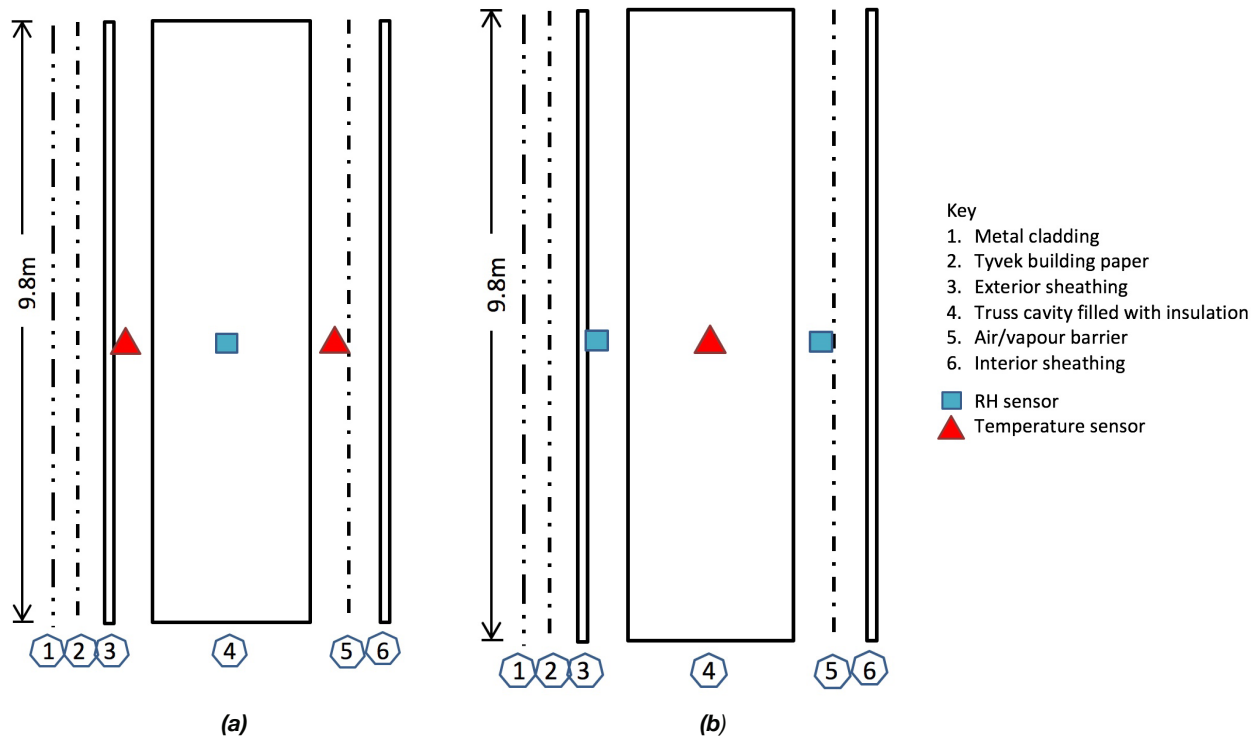
Four separate arrangements of sensors in the north wall were configured with two temperatures and one humidity sensor (N01, N02, N05 and N06) (Figure 15a), and two arrangements were configured with two humidity and one temperature sensors (N03 and N04) (Figure 15b). For configurations N01, N02, N05 and N06, the temperature sensors are located on the exterior face of the interior OSB sheathing layer and the interior face of the exterior OSB sheathing layer, with the humidity sensor located in the center of the insulated assembly. The two additional sensor configurations, N03 and N04, were configured with two humidity sensors and one temperature sensor. Here, the two humidity sensors are located on the exterior face of the interior OSB sheathing layer and the interior face of the exterior OSB sheathing layer, with the temperature sensor located in the center of the insulated assembly.

Figure 15. Sensor placement in exterior north and south wall assembly of WIRL building. Sensor groups N01, N02, N05 and N06 and S01, S02, S05 and S06 are configured as shown in (a). Sensor groups N03 and N04 S03 and S04 are configured as shown in (b).

Four separate arrangements of sensors in the south wall were configured with two temperature and one humidity sensor (S01, S02, S05 and S06) (Figure 15a), and two arrangements were configured with two humidity and one temperature sensors (S03 and S04) (Figure 15b). For configurations S01, S02, S05 and S06, the temperature sensors are located on the exterior face of the interior OSB sheathing layer and the interior face of the exterior OSB sheathing layer, with the humidity sensor located in the center of the insulated assembly. The two additional sensor configurations, S03 and S04, were configured with two humidity sensors and one temperature sensor. Here, the two humidity sensors are located on the exterior face of the interior OSB sheathing layer and the interior face of the exterior OSB sheathing layer, with the temperature sensor located in the center of the insulated assembly.

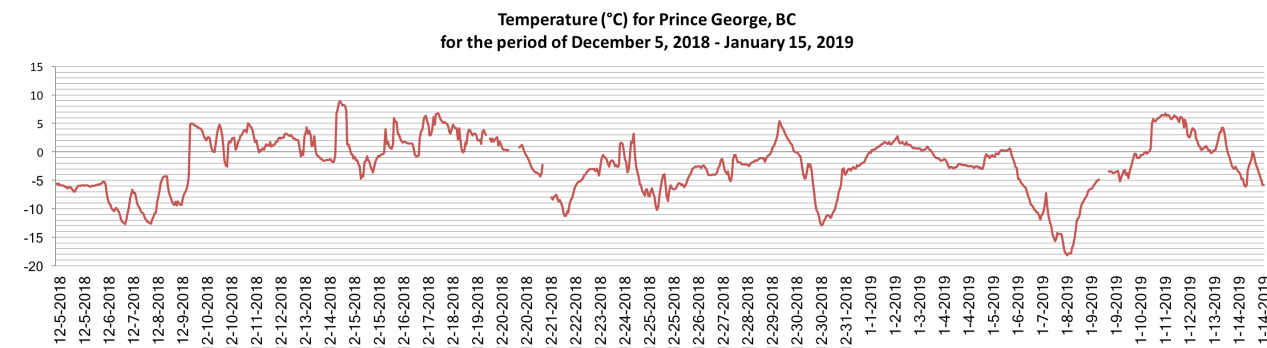
Figure 16. Hourly temperature (°C) for Prince George from Dec. 5, 2018 to Jan. 15, 2019 (Government of Canada, 2019).

The four remaining sensor groups located in the south wall of the WIRL building show that at no point during the period of July 18, 2018 to Jan. 12, 2019 was 100 percent saturation (relative humidity) achieved in the wall assembly (Table 8-10). The maximum relative humidity value recorded was by sensor S03 on Jan. 7, 2019 at 17:00 at 94.24% (Table 9a). Similar to the findings of the data reported in the north wall sensors, this value correlates with one of the coldest exterior weather periods reported for the reporting period (Figure 16).

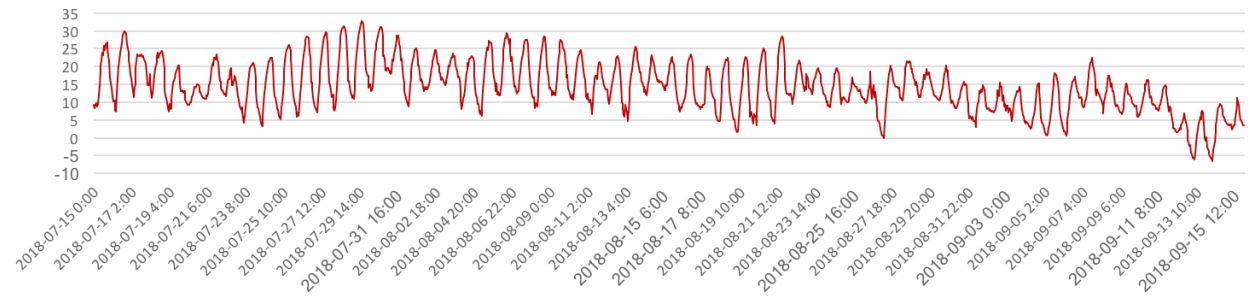
Figure 17. Hourly temperature ( $^{\circ}\text{C}$ ) for Prince George from July 15 to Sept. 15, 2019 (Government of Canada, 2019).

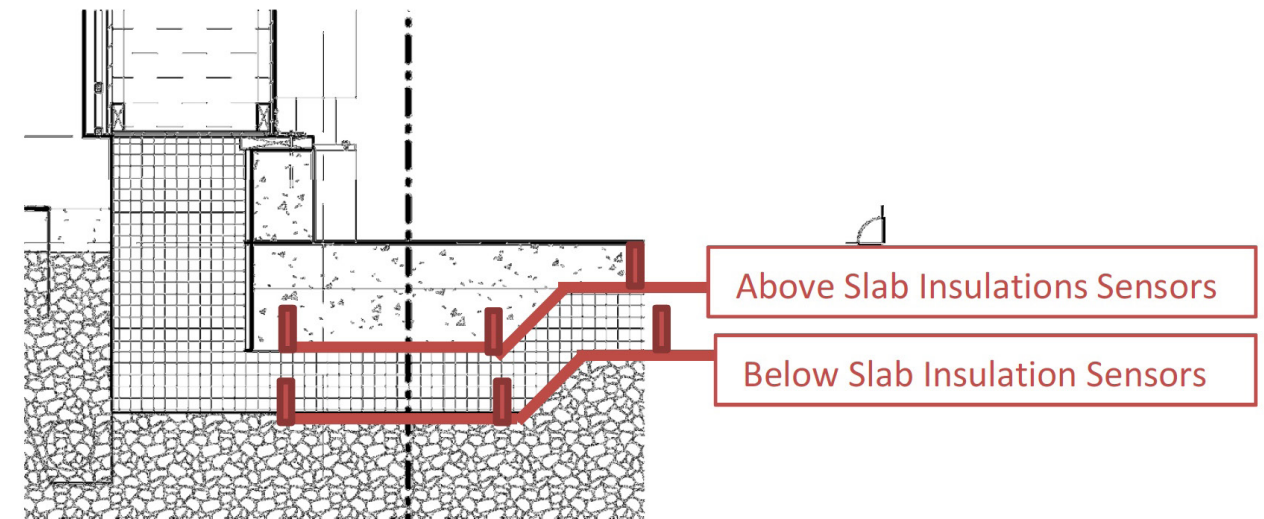
Six strings of temperature and humidity sensors were installed in a layered grid along the southwest corner of the foundation. The sensor configurations were laid out in parallel lines located in the floor of the conditioning room in the southwest corner of the building, with each line comprising of two sets of six sensors stacked on top of each other above and below the foundation insulation installed under the concrete floor (Figure 18 and 19). This setup allows for an accurate monitoring of heat transfer through the foundation into the soil. This particular location was chosen to use the advantage of the conditioning room because only in this room will the temperature and humidity be stably maintained through the entire year.

Figure 18. WIRL floor sensor configuration. Sensors are located in a stacked format in two separate parallel lines located in the southwest corner of the building floor.

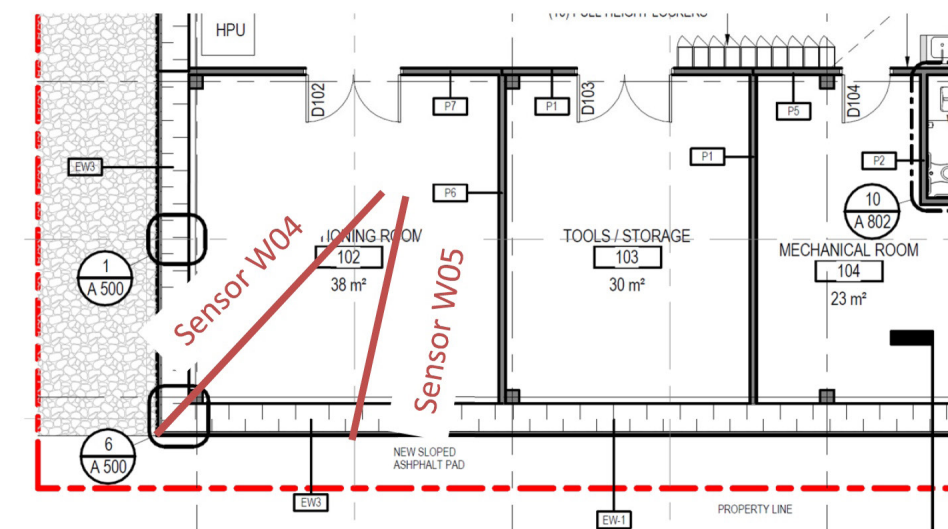
Figure 19. WIRL floor sensor configuration. Sensors are located in a stacked format in two separate parallel lines (labeled as Sensor W04 and W05) located in the southwest corner of the building floor.

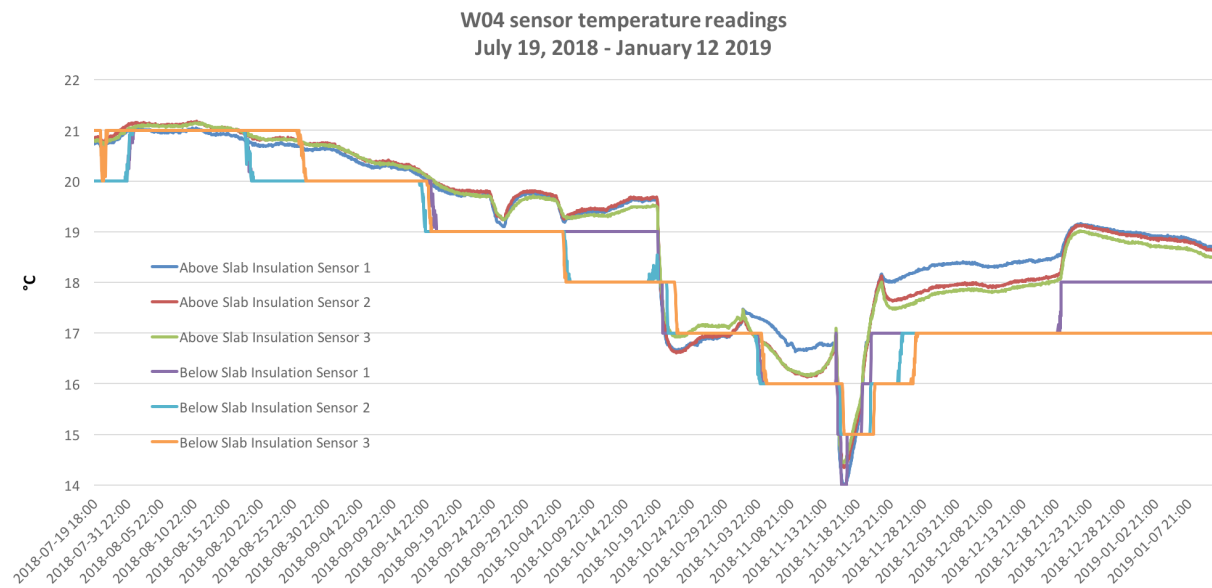
The results of the readings from the six sensors in each of the floor sensor configurations are shown in Figure 20 and 21.

Figure 20. W04 floor sensor temperature readings for the period of July 19, 2018 to Jan. 12, 2019.

From the data recorded by the sensors in configuration W04 and W05, we can see a consistent pattern of temperature recordings between the three sensors located above the slab insulation and the three located below. While the temperature in the conditioning room (room 102) is set to maintain 20 degrees Celsius, we can see the effects that the exterior temperature plays on the sensors located below the slab as the ground cools and pulls heat away from the building. We see the effects of this on the values recorded by the sensors as there is a general downward trend in the reported values between the dates of July 19 2018 and Jan. 12, 2019 of approximately 2C as the exterior air temperature and ground temperature decrease.

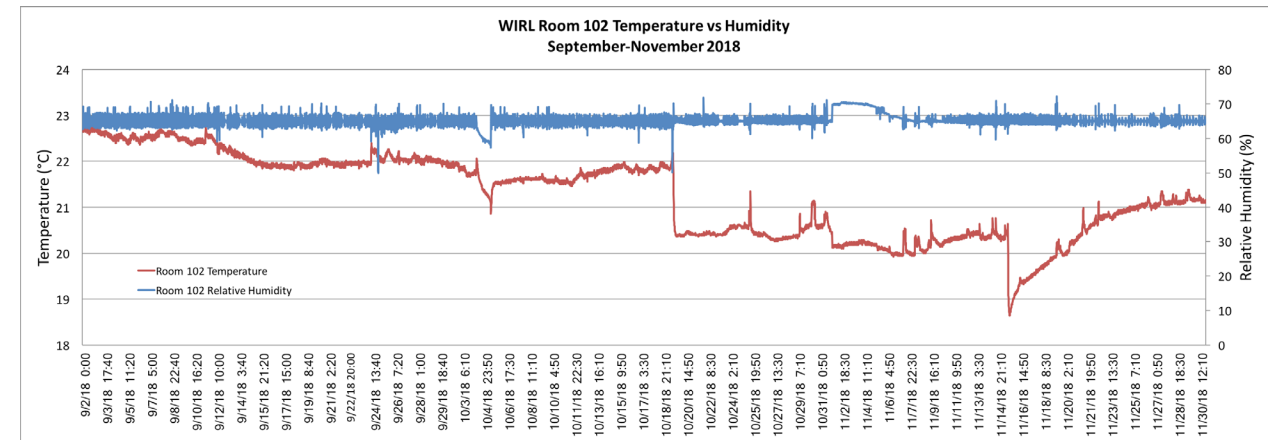
Figure 22. WIRL room 102 temperature and relative humidity readings for the period of Sept. 2 to Nov. 30, 2018.

We can see that two large discrepancies exist in the W04 and W05 sensor data on Oct. 19 and Nov. 15, 2018. These are found to correlate with the temperature records which were recorded in the room over the same period (Figure 22). Due to the room's use for storing wood and materials for testing in the lab, it is believed that these occurrences correspond to the door to the room being left open during material movement in and out of the room for research or testing purposes. The temperature drop in the room sensors occurs with a delay to the drop in temperature in the room, indicating the time delay that occurs in the cooling of the concrete slab to meet the room temperature.

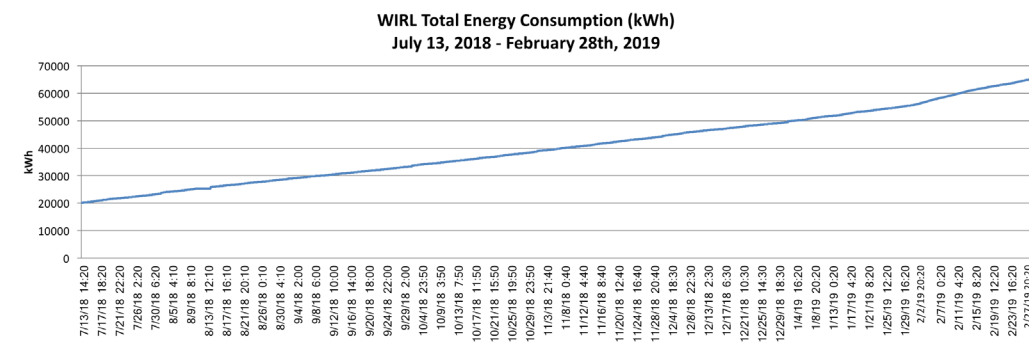
The cumulative energy consumption for the WIRL building has been recorded since July 13th, 2018. The total energy consumption of the building on Feb. 28, 2019 was 65,166.36kWh of energy (Figure 24).

Figure 24. WIRL total cumulative energy consumption (kWh) for the period of July 13, 2018 to Feb. 28, 2019.

At the time energy consumption readings began, an initial 20,127.22kWh of energy had already been consumed. It is unknown when the actual start date for this energy consumption began, and whether it included construction work being done in the building before completion. Therefore, when calculating the average energy consumption per month, this initial energy consumption was removed.
