EVALUATING FIRE PERFORMANCE OF NAIL-LAMINATED TIMBER

March 10, 2019

Client: Forestry Innovation Investment Ltd.

EVALUATING FIRE PERFORMANCE OF NAIL LAMINATED
TIMBER
PROJECT NO. 301013024

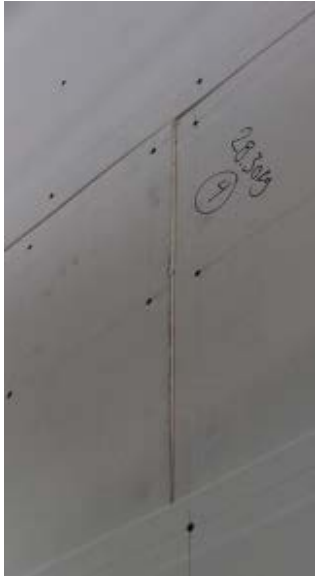
Figure 11. 2x8 NLT Gypsum board disparity.

The NLT surface was not perfectly level due to natural variability of the boards and manufacturing methods. This meant that in some cases that gypsum board joints did not meet straight on, where one protruded out further than the adjacent board, as shown in Figure 11. This created a disparity at the joint and an air gap behind the gypsum board in some locations. The final exposed surface of the 2x8 NLT wall assembly is shown in Figure 12.

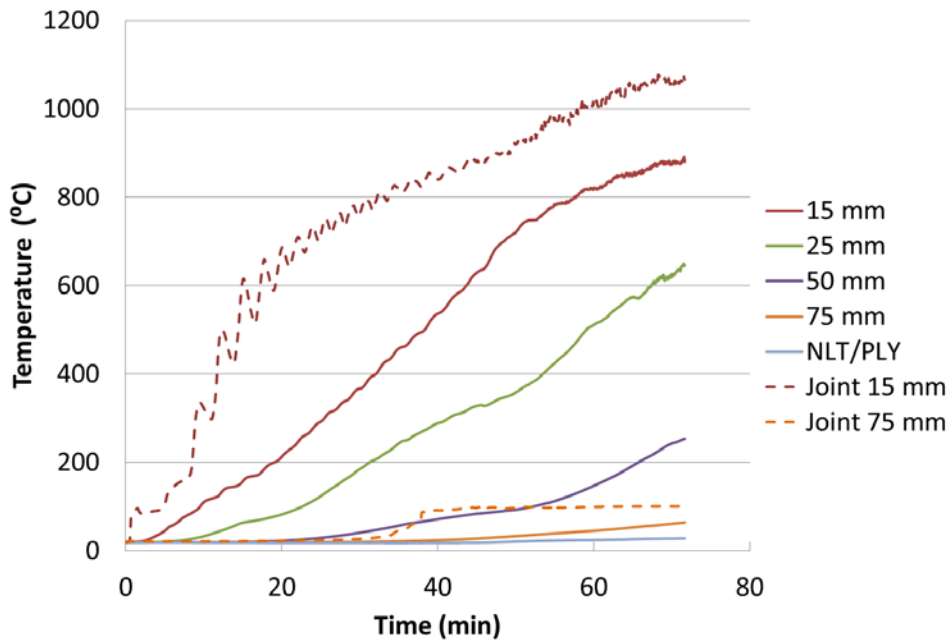
Figure 24. 2x6 NLT wall average temperatures at embedded thermocouple locations.

The average furnace temperature during the test is shown in Figure 23. Average embedded thermocouple temperatures (for depths of 15 mm, 25 mm, 50 mm, and 75 mm) are shown in Figure 24; in this figure thermocouple measurements in the joint are depicted by a dashed line. The thermocouple 15 mm deep at location B (2-B-15) malfunctioned between 41 to 46 min and the thermocouple 25 mm deep at location B (2-C-25) also malfunctioned; this data was not included in the plot.

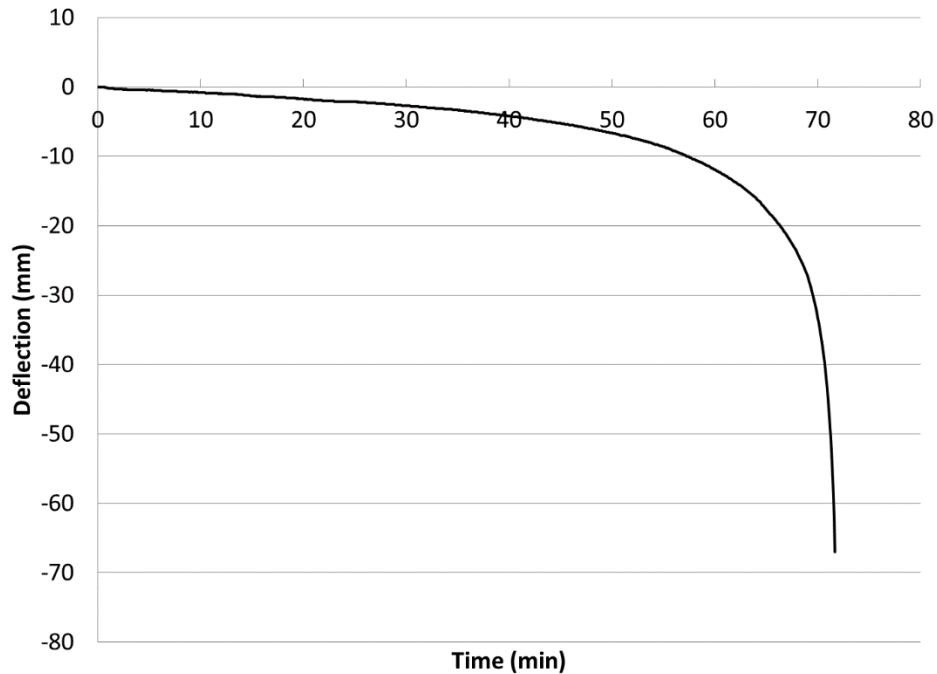
Figure 25. 2x6 NLT wall maximum deflection.

At failure, the maximum deflection was 67 mm at mid-height (not including initial preload deflection). Maximum deflection throughout the test is shown in Figure 25.

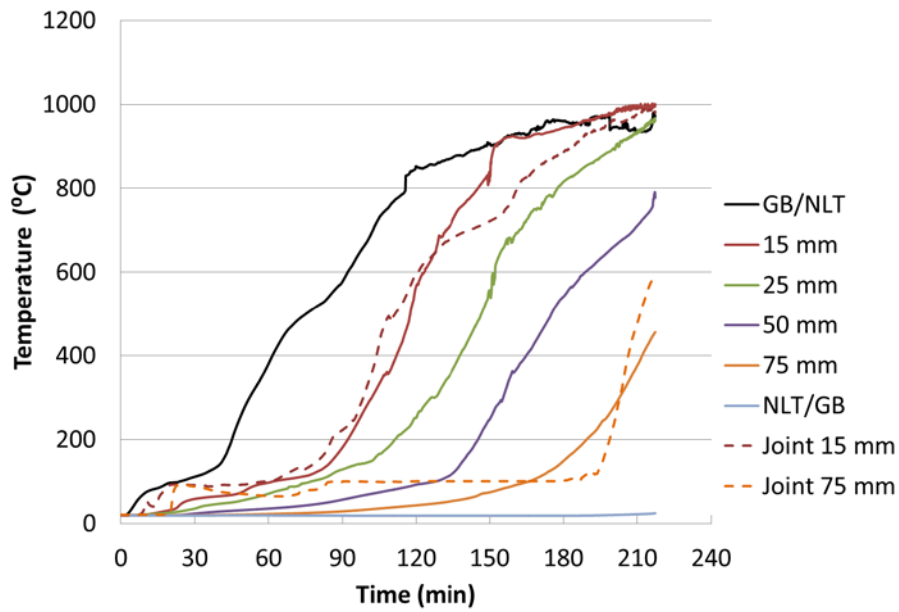
Figure 34. 2x8 NLT wall average temperatures at embedded thermocouple locations.

The average furnace temperature during the test is shown in Figure 33. Average embedded thermocouple temperatures (for depths of 15 mm, 25 mm, 50 mm, and 75 mm) are shown in Figure 34; in the figure thermocouple measurements in the joint are depicted by a dashed line. The thermocouple embedded 15 mm at location A (TC 1-A-15) was not included in the average plot because it malfunctioned.

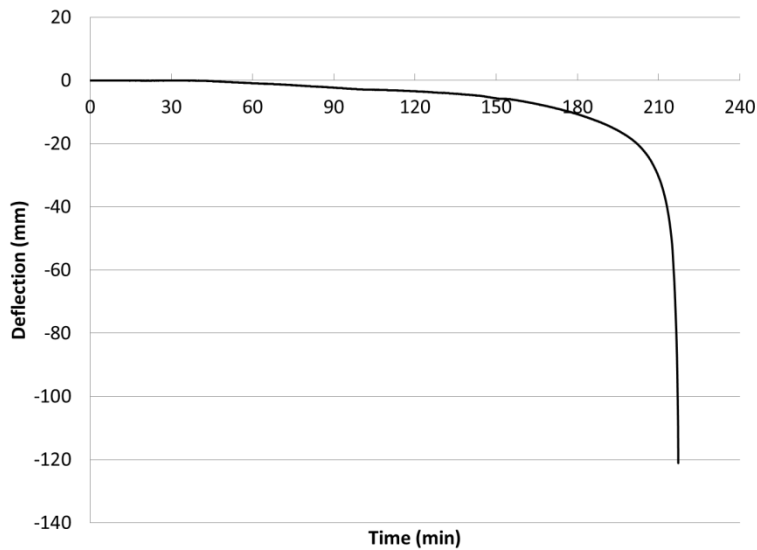
Figure 35. 2x8 NLT wall maximum deflection.

At failure, the maximum deflection was 120 mm at mid-height (not including the initial preload deflection). Maximum deflection throughout the test is shown in Figure 25.

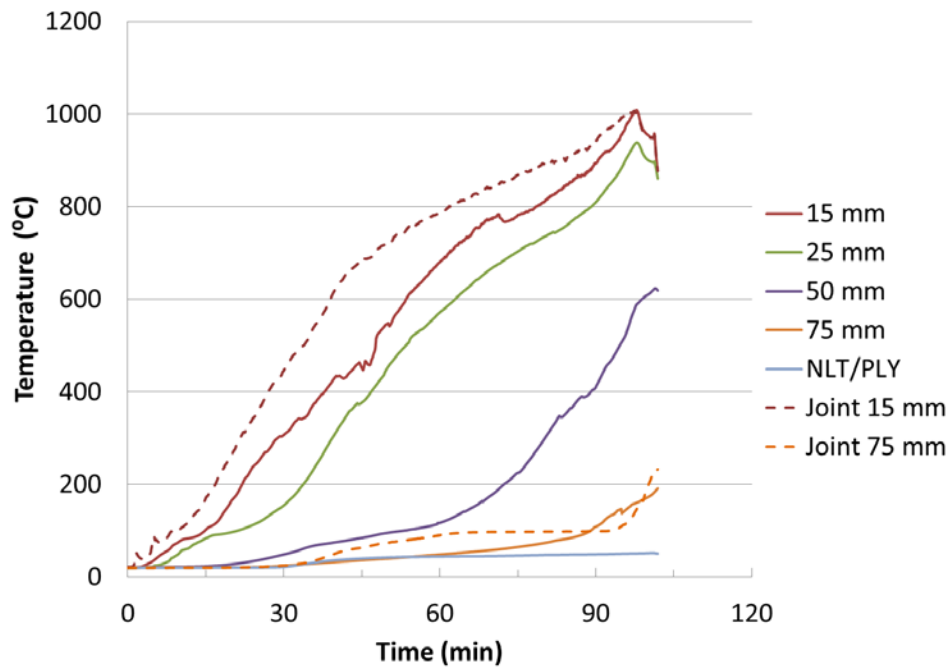
Figure 43. 2x6 NLT floor average temperatures at embedded thermocouple locations.

Average embedded thermocouple temperatures (for depths of 15 mm, 25 mm, 50 mm, and 75 mm) are shown in Figure 43; in the figure thermocouple measurements in the joint are depicted by a dashed line. Embedded thermocouples up to 25 mm experienced a similar peak and decrease in temperature as was noted for several furnace temperatures. The thermocouple at 75 mm at location A (5-A-75) appeared to malfunction after 95 min, this data is not included in the average plot.

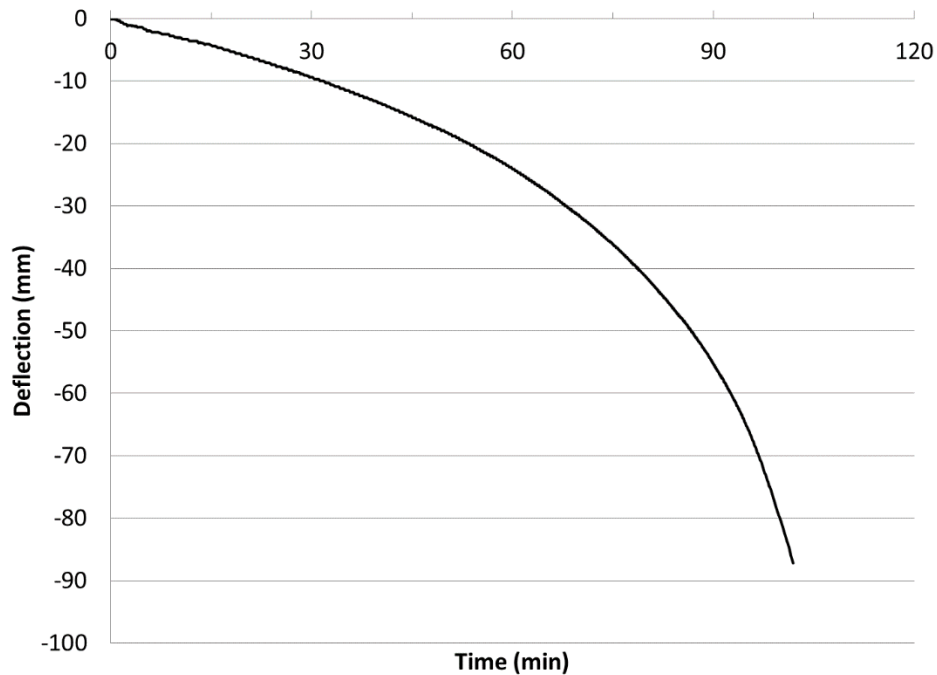
Figure 44. 2x6 NLT floor maximum deflection.

The maximum measured temperature increase from thermocouples on the unexposed side was 24°C. At failure, the maximum deflection was 87 mm, measured at mid-length (not including initial pre-load deflection). Maximum deflection throughout the test is shown in Figure 44.

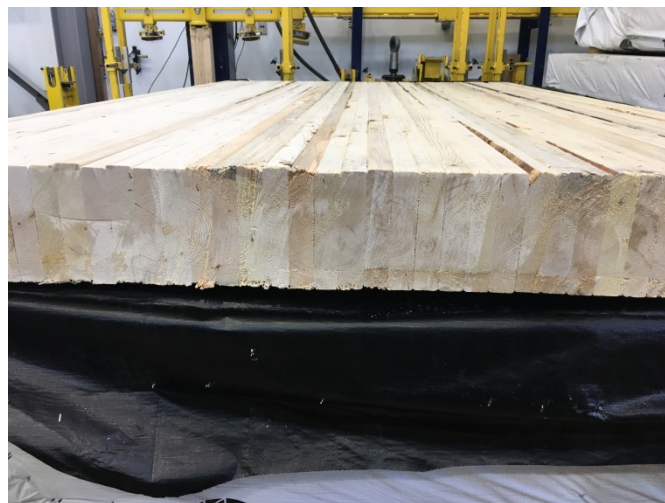
Figure 52. Cross-section of NLT.

Because of the nature of NLT as a product, using multiple lumber boards laminated together, the natural imperfections in the lumber can impact the quality of the assembly. There are various defects that are typical in lumber such as twisting, cupping, bowing, wane, etc. These can result in two boards not pressed in full contact with each other, which can create gaps or pockets between the boards which can lead to localized increased charring rates. Figure 49 to Figure 51 show examples of gaps that formed during construction of these assemblies. Care should be taken in the selection of boards for use in NLT to limit the creation of these kinds of gaps. It may be prudent to press boards together during nailing, to increase contact between boards to improve quality and fire resistance. Moisture content of boards should be monitored to avoid unnecessary creation of gaps due to wood shrinkage once assemblies are in service. These measures will help to minimize and limit the size and number of gaps between boards, which should reduce the possibility of integrity failures. Additional layers of protection on the unexposed side which create an air barrier may also limit charring at these gaps if it prevents airflow through the system. A cross-section of NLT is shown in Figure 52, indicating that the surface is not perfectly smooth. This can affect the application of direct applied gypsum board, but creating local air gaps behind the board. More research is warranted to investigate methods to address local integrity failure in NLT assemblies.
